TRANSOCEAN SEDCO 702 MODU

Repair of Impact Damage, North West Shelf

Replacement of Chain Locker on the Sedco 702 MODU, 1999

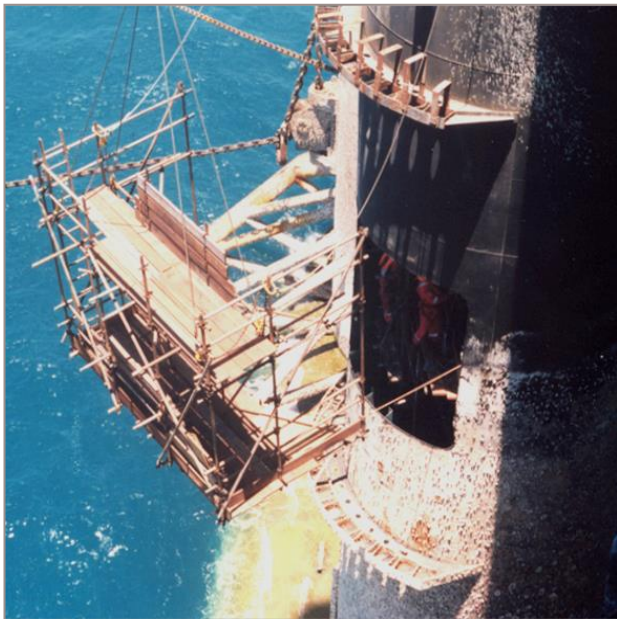
Icon Engineering was commissioned to project manage and execute repair of vessel impact damage to a stability column on the Sedco 702 rig.

Lifting the prefabricated scaffold into place

The work required a patch approximately 4m square to be cut from the column and replaced with a prefabricated patch.

A key feature of the work was the prefabricated scaffold which was assembled onshore and brought out in a single piece.

This allowed work to be carried out on the opening immediately the damaged shell section had been cut away. The scaffold was designed to allow the new patch to be lowered into place between the scaffold and the column.

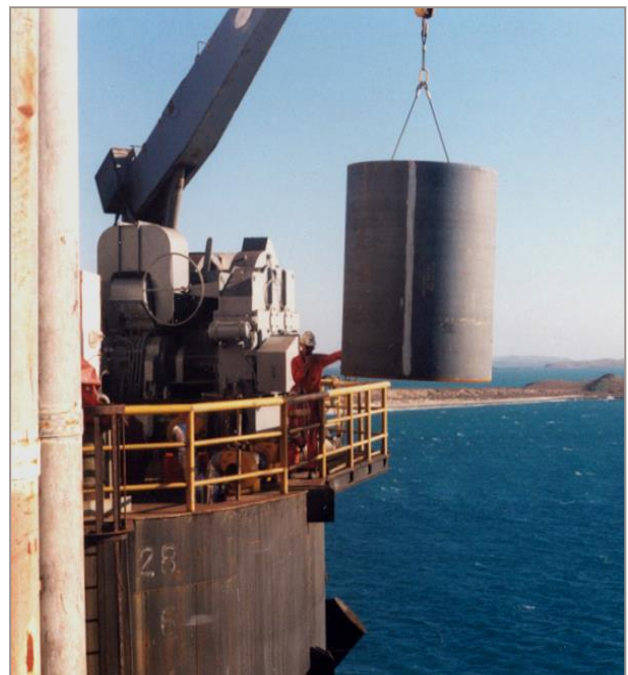
ICON was commissioned by Sedco to replace a chain locker on the Sedco 702 MODU. The work involved preparation of the procedure, material procurement, prefabrication of the locker segments and execution of the work offshore.

Lifting a section of the chain locker through the deck opening

A key feature of the job was the planning to allow for the removal of the old sections and installation of the new sections within the highly stiffened column.

This required access hatches to be cut and a transfer system to be set up to allow the sections to be moved in and out of the chain locker.
