Repair Of Vessel Impact Damage To The Sedco 702 Modu. 1999

Schlumberger Oilfield Australia

Replacement Of Chain Locker On The Sedco 702 Modu. 1999

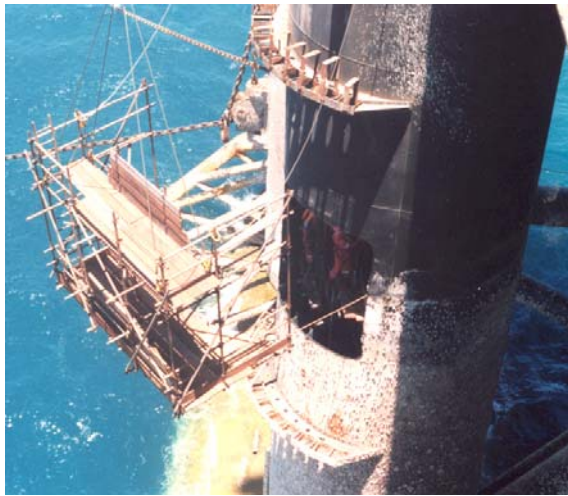
Lifting the prefabricated scaffold into place.

The work required a patch approximately 4m square to be cut from the column and replaced with a prefabricated patch. A key feature of the work was the prefabricated scaffold which was assembled onshore and brought out in a single piece. This allowed work to be carried out on the opening immediately the damaged shell section had been cut away. The scaffold was designed to allow the new patch to be lowered into place between the scaffold and the column.

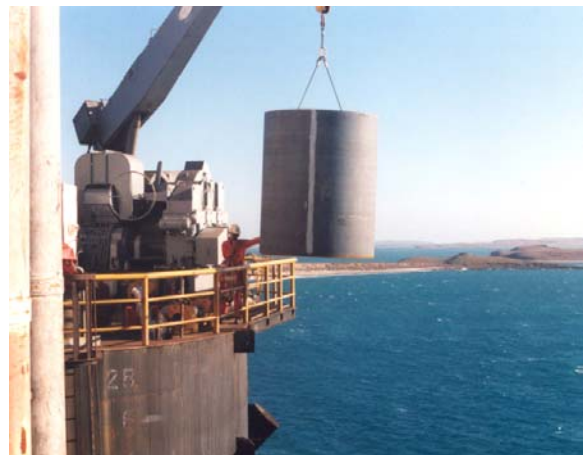
Lifting a section of the chain locker through the deck opening

A key feature of the job was the planning to allow for the removal of the old sections and installation of the new sections within the highly stiffened column. This required access hatches to be cut and a transfer system to be set up to allow the sections to be moved in and out of the chain locker.
